# 2019 Ford Fusion Hybrid SE

Anonymized inspection findings and selected photographs for a public second opinion.

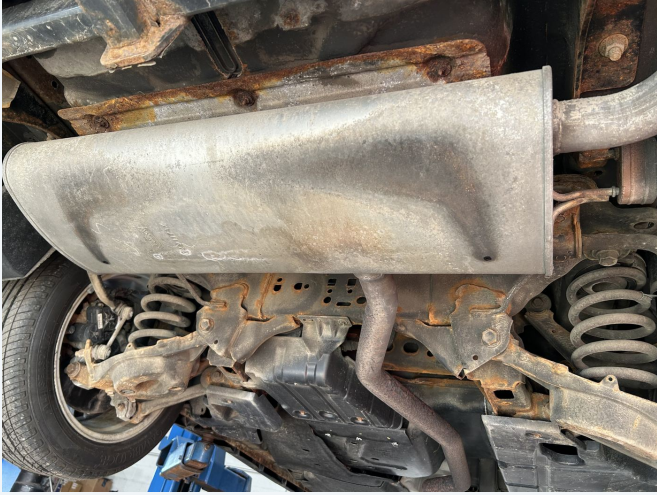
**01 | Inspection photo**

Rear underside, exhaust and suspension overview.

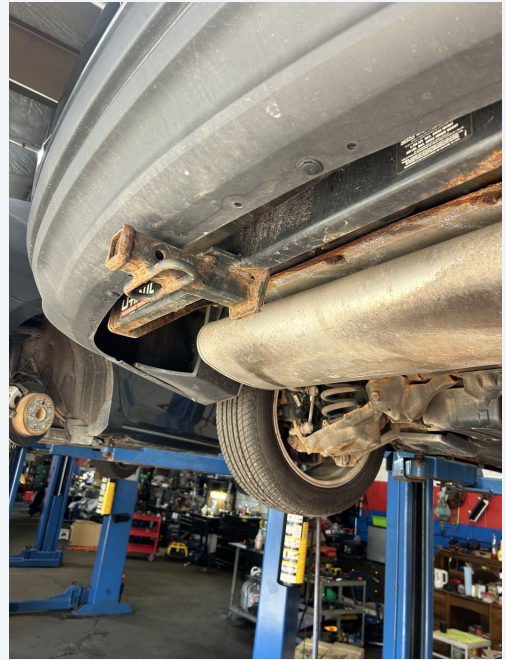
**02 | Inspection photo**

No abnormal transmission or bearing noise was detected during cold-start and running checks. A trailer-hitch receiver was present. That alone does not prove the car was used to tow, how much it towed, or that the transmission is damaged.

Rear underside, hitch and nearby metalwork.

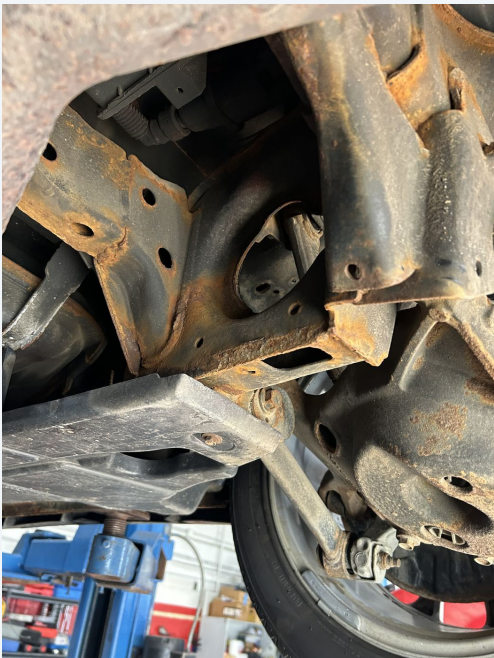
**03 | Inspection photo**

Rust was observed on the underbody and chassis/frame areas. The shop noted earlier use in a region where road salt is relevant. The report explicitly says that the presence of rust alone does not establish its effect on structural integrity. The photos should be assessed for the condition of structural members, mounting points, lines and fasteners without assuming a structural failure has been proven.

Underbody suspension/mounting area and corrosion.

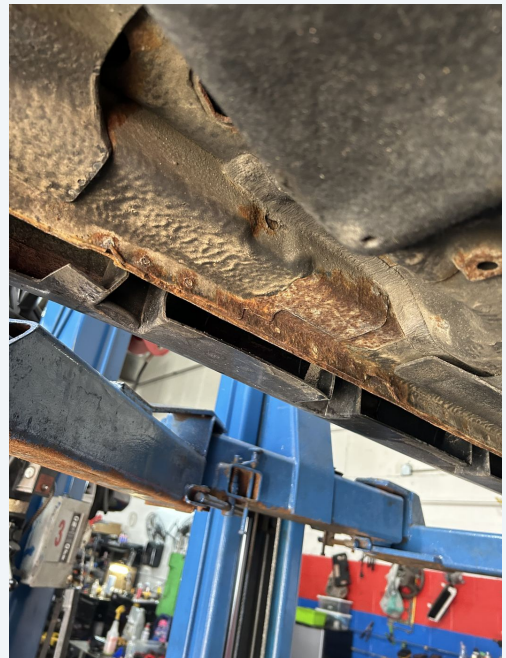
**04 | Inspection photo**

Underbody metalwork and visible corrosion.

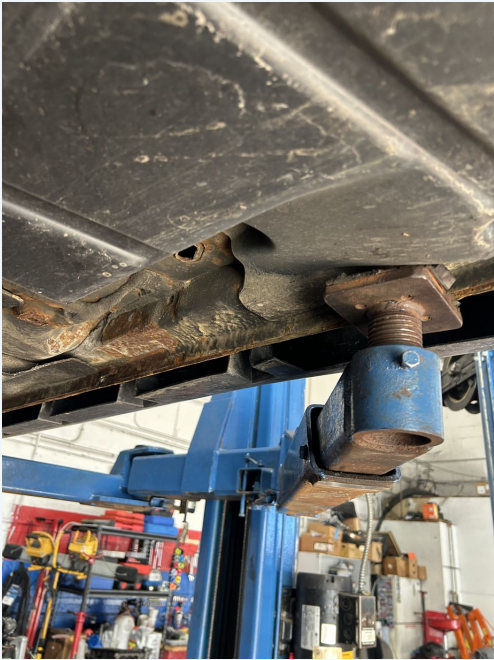
**05 | Inspection photo**  
Underbody panel and adjacent structure.

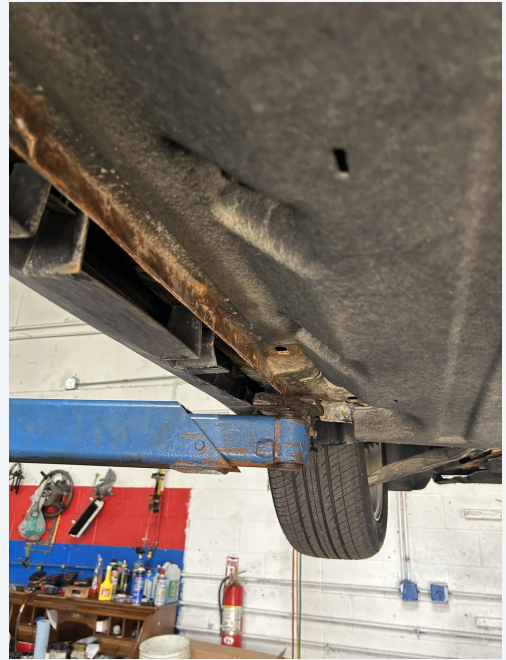
**06 | Inspection photo**  
Underbody covering and adjacent metalwork.

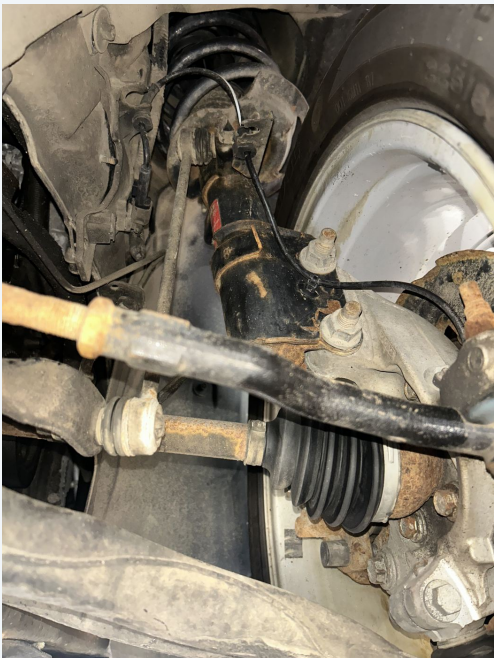
**07 | Inspection photo**  
Front wheel, suspension and steering components.

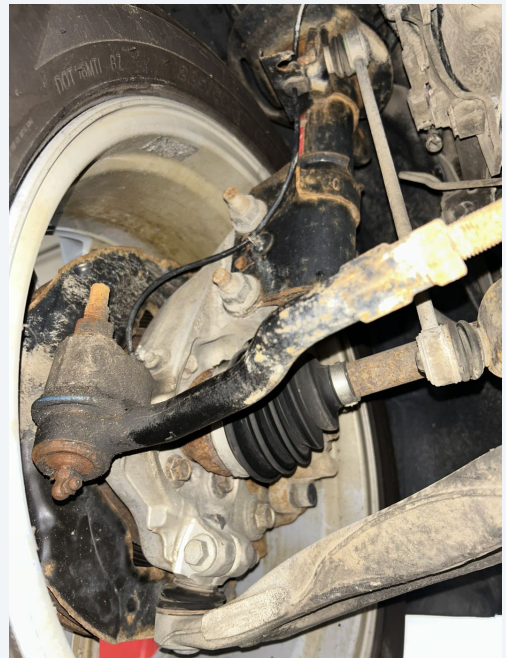
| Item | What the shop reported |
|---|---|
| Left-front steering area | Leakage near the left-front tie-rod area. No noise present at the time; future replacement was recommended. The written report does not establish the precise leaking component. |

**08 | Inspection photo**  
Front suspension and steering close-up.

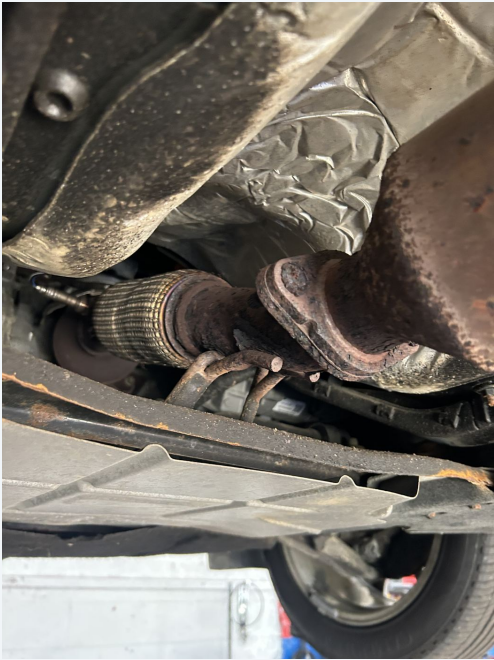
**09 | Inspection photo**  
Exhaust flex section and engine underside.

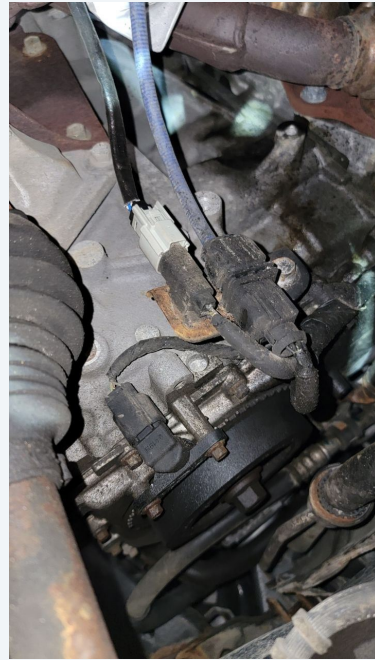
**10 | Inspection photo**  
Engine underside/filter-area close-up supplied by the shop.

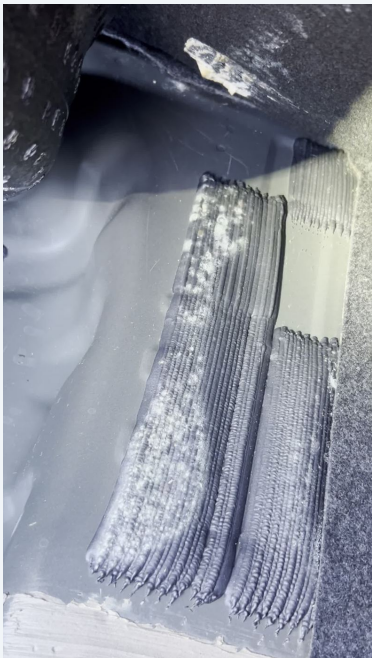
The report references CARFAX rear damage and evidence of repainting on the rear bumper. Mold-like growth was observed on one side of the trunk area and documented in video. No standing water was present during inspection. Previous water intrusion was suspected, potentially related to the rear incident; the source and repair status were not confirmed. Further inspection and cleanup were recommended.

**11 | Inspection photo**  
Still from inspection video: trunk lining; report notes mold-like marks.

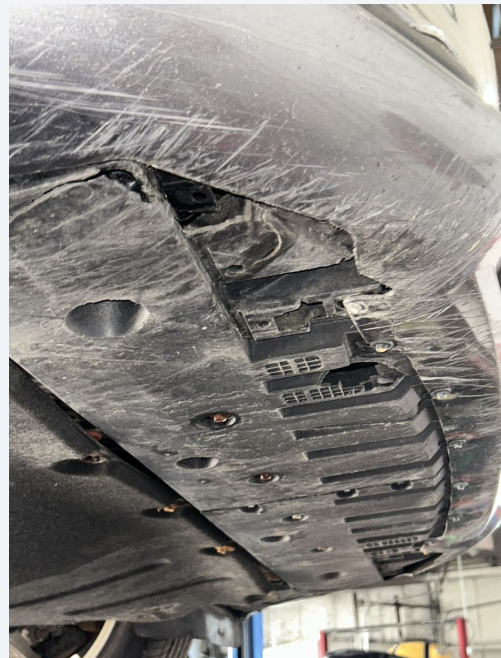
Scratches and other exterior marks; cracked/damaged plastic housings on both mirrors; interior stains. The lower splash shield was described as broken in the buyer's follow-up summary. No hood insulation pad was present; the inspector noted that some cars of this year were supplied without one.

**12 | Inspection photo**  
Damaged/scuffed lower undertray.

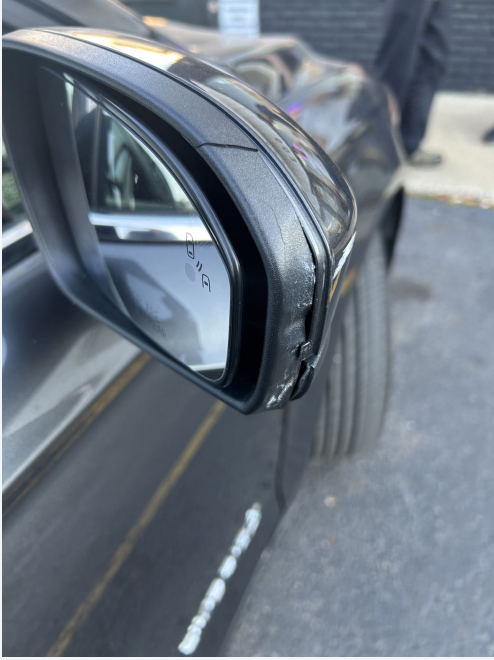
**13 | Inspection photo**  
Exterior mirror housing with cracking visible.

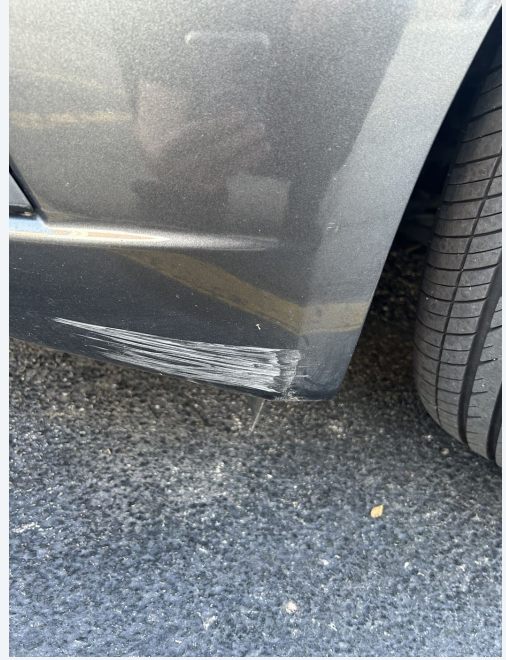
**14 | Inspection photo**  
Scuffing near a lower bumper corner.

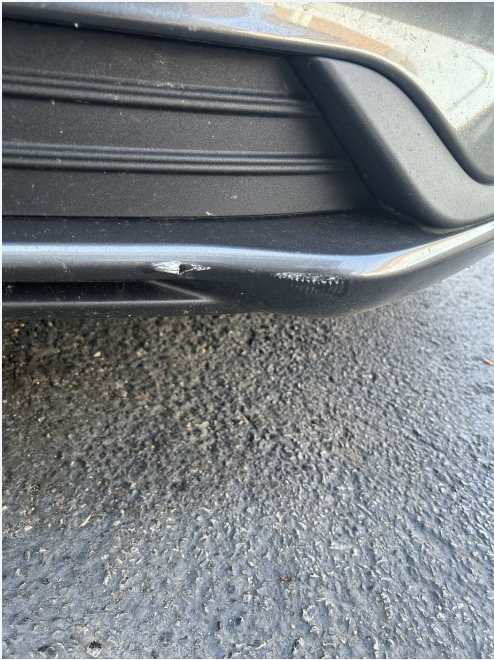
**17 | Inspection photo**  
Lower front bumper trim and scuffing.

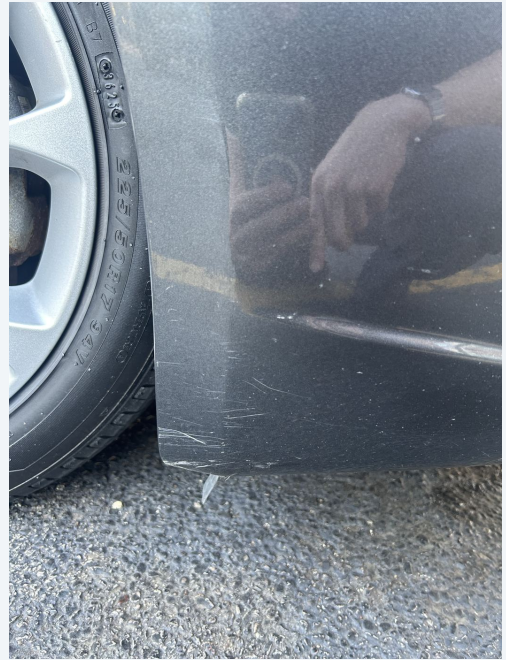
**18 | Inspection photo**  
Body scuff near a wheel opening.

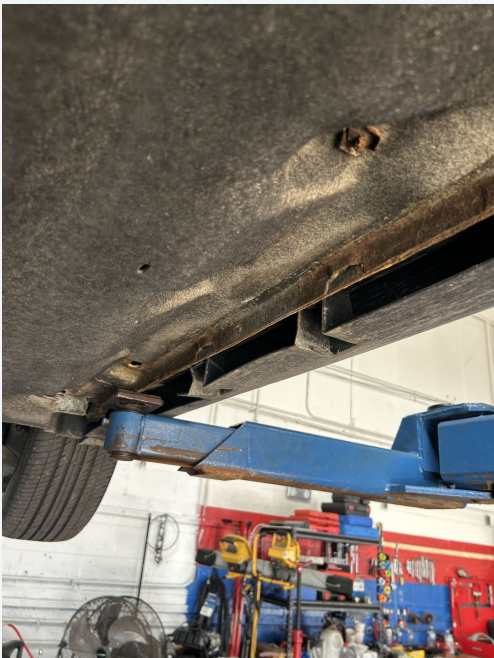
**31 | Inspection photo**  
Underbody covering and fasteners.

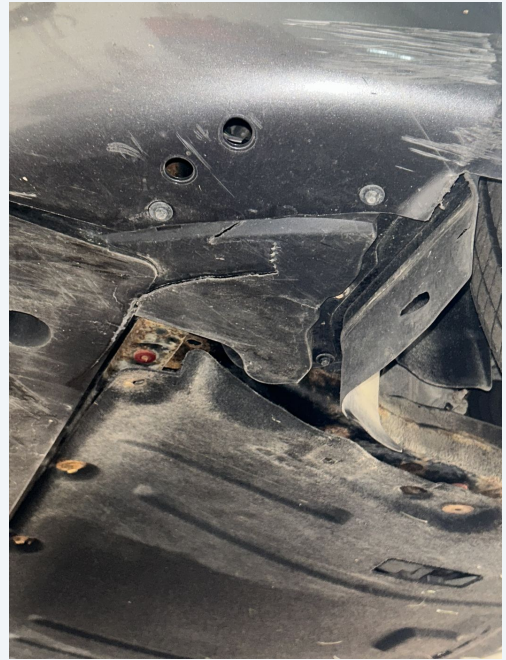
**34 | Inspection photo**  
Lower undertray and openings.
